**DEPARTMENT OF TRANSPORTATION****DIVISION OF ENGINEERING SERVICES**

Contract #: 04-0120F4Cty: SF/ALA Rte: 80 PM: 13.2/13.9File #: 69.28**WELDING INSPECTION REPORT****Resident Engineer:**Pursell, Gary**Address:** 333 Burma Road**City:** Oakland, CA 94607**Report No:** WIR-000570**Date Inspected:** 02-Oct-2007**Project Name:** SAS Superstructure**OSM Arrival Time:** 630**Prime Contractor:** American Bridge/Fluor Enterprises, a JV**OSM Departure Time:** 1530**Contractor:** Zhenhua Port Machinery Company, Ltd (ZPMC), Changxing Island **Location:** Shanghai, China**CWI Name:** Xu Bing**CWI Present:** Yes No**Inspected CWI report:** Yes No N/A**Rod Oven in Use:** Yes No N/A**Electrode to specification:** Yes No N/A**Weld Procedures Followed:** Yes No N/A**Qualified Welders:** Yes No N/A**Verified Joint Fit-up:** Yes No N/A**Approved Drawings:** Yes No N/A**Approved WPS:** Yes No N/A**Delayed / Cancelled:** Yes No N/A**Bridge No:** 34-0006**Component:** Mock Up/Verify Production Plate**Summary of Items Observed:**

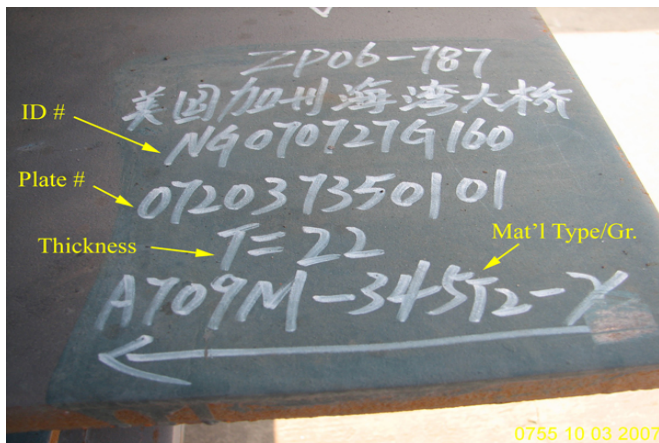
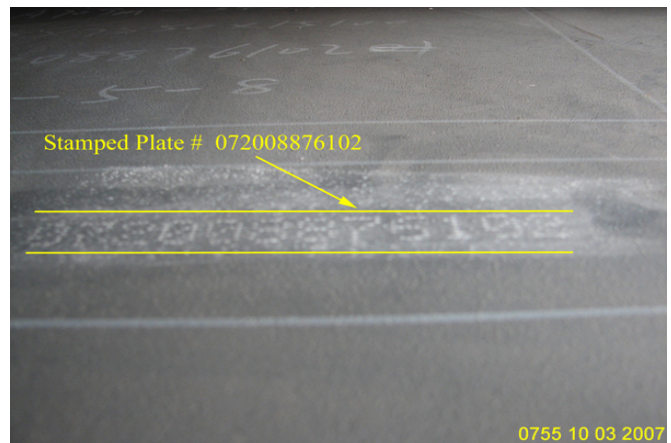
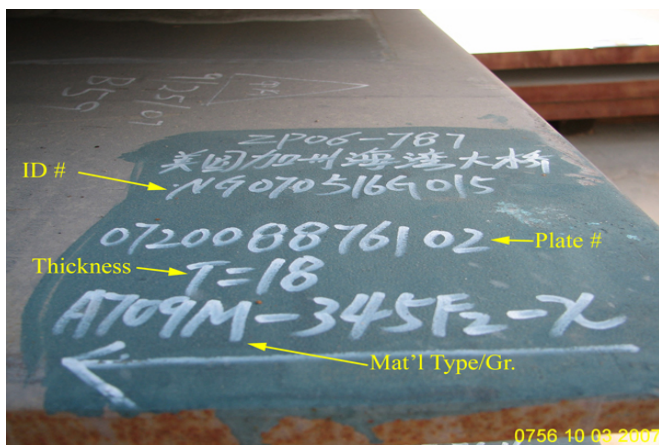
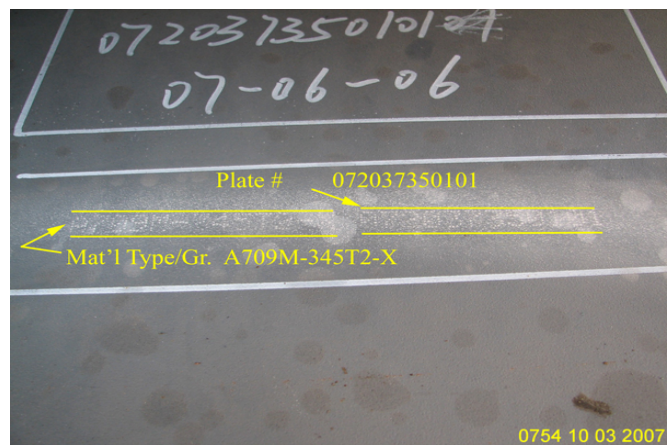
The QA Inspector was present at the time requested to verify tracability of steel production plate in the steel plate storage yard. The QA Inspector was accompanied by Jeff Evans of American Bridge/Fluor Enterprises, a JV, along with ZPMC Quality Representatives Li Xiu Yang and Wu Min. The QA Inspector verified an 18 millimeter (mm) thick ASTM A709M-345T2-X steel production plate with the Plate number 072008876102 and ID number NG070516G015, and a 22 mm thick ASTM A709M-345T2-X steel production plate with the Plate number 072037350101 and ID number of NG070727G160. Each steel production plate was stamped with the applicable Plate number and the Plate numbers along with the ID numbers were written in several locations on each plate with paint stick. The Plate numbers of both the 18 mm and 22 mm thick steel production plates, matched the Plate numbers on the applicable Material Test Reports. The attached photographs provide additional detail. The photographs were retaken on 10-03-2007 because the ones that were taken on 10-02-2007, were not good enough to print out legibly on this report.
